# Monumental stairway to history preserved

In Frederick Olmsted-designed Walnut Hill Park (1870), the town erected a 90-foot limestone obelisk to remember its lost sons. Monument architect H. Van Buren Magonigle designed the slim stone obelisk in 1930. A year later, he added the graceful, curving Indiana limestone stairway which ascends the 100-foot slope to the monument.

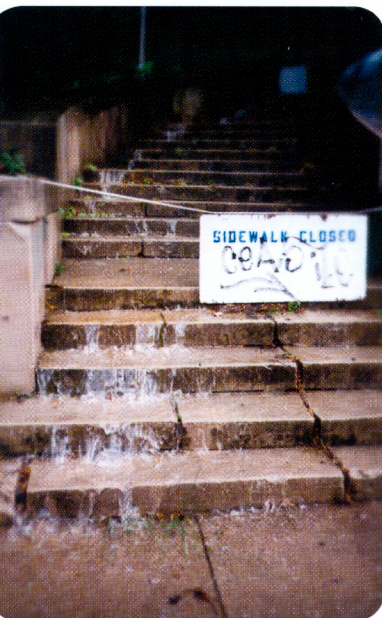
Water from improper drainage gradually undermined the stairway's concrete underpinnings. Atmospheric soiling, biological staining, birds, litter bugs and graffiti vandals attacked its appearance. The city blocked access, for safety, in 1987. For 15 years, the once monumental stairway slowly sank ever more deeply into disrepair.

Left: For 15 years, the stairway slowly sank into disrepair. Above: The restored stairway curves up the Walnut Hill Park hillside.

Restoration work on the stairs began with designing corrected drainage. "We regraded the slope to catch water and redirect it away from the stairs," said Mr. Barlow.

For cleaning, Mr. Barlow specified PROSOCO's Sure Klean® 766 Limestone & Masonry Prewash, followed by Sure Klean® Limestone & Masonry Afterwash. He chose Defacer Eraser® Graffiti Wipe to strip years of graffiti from the venerable stone, and sacrificial Defacer Eraser® Graffiti Barrier S to protect the cleaned stones from further attack.

With the stairway cleaned, the stage was set for repairs. Over the next three weeks, the crew repointed the old stairway, and patched damaged areas with a specially blended mortar.
